Subject: Homewood Mountain Resort Ski Area Master Plan EIR/EIS
Methodology for Tracking Land Coverage Banking

Homewood Mountain Resort Road Coverage Removal Summary

Prepared by Kevin Drake and Heather Beckman
Integrated Environmental Restoration Services, Inc.

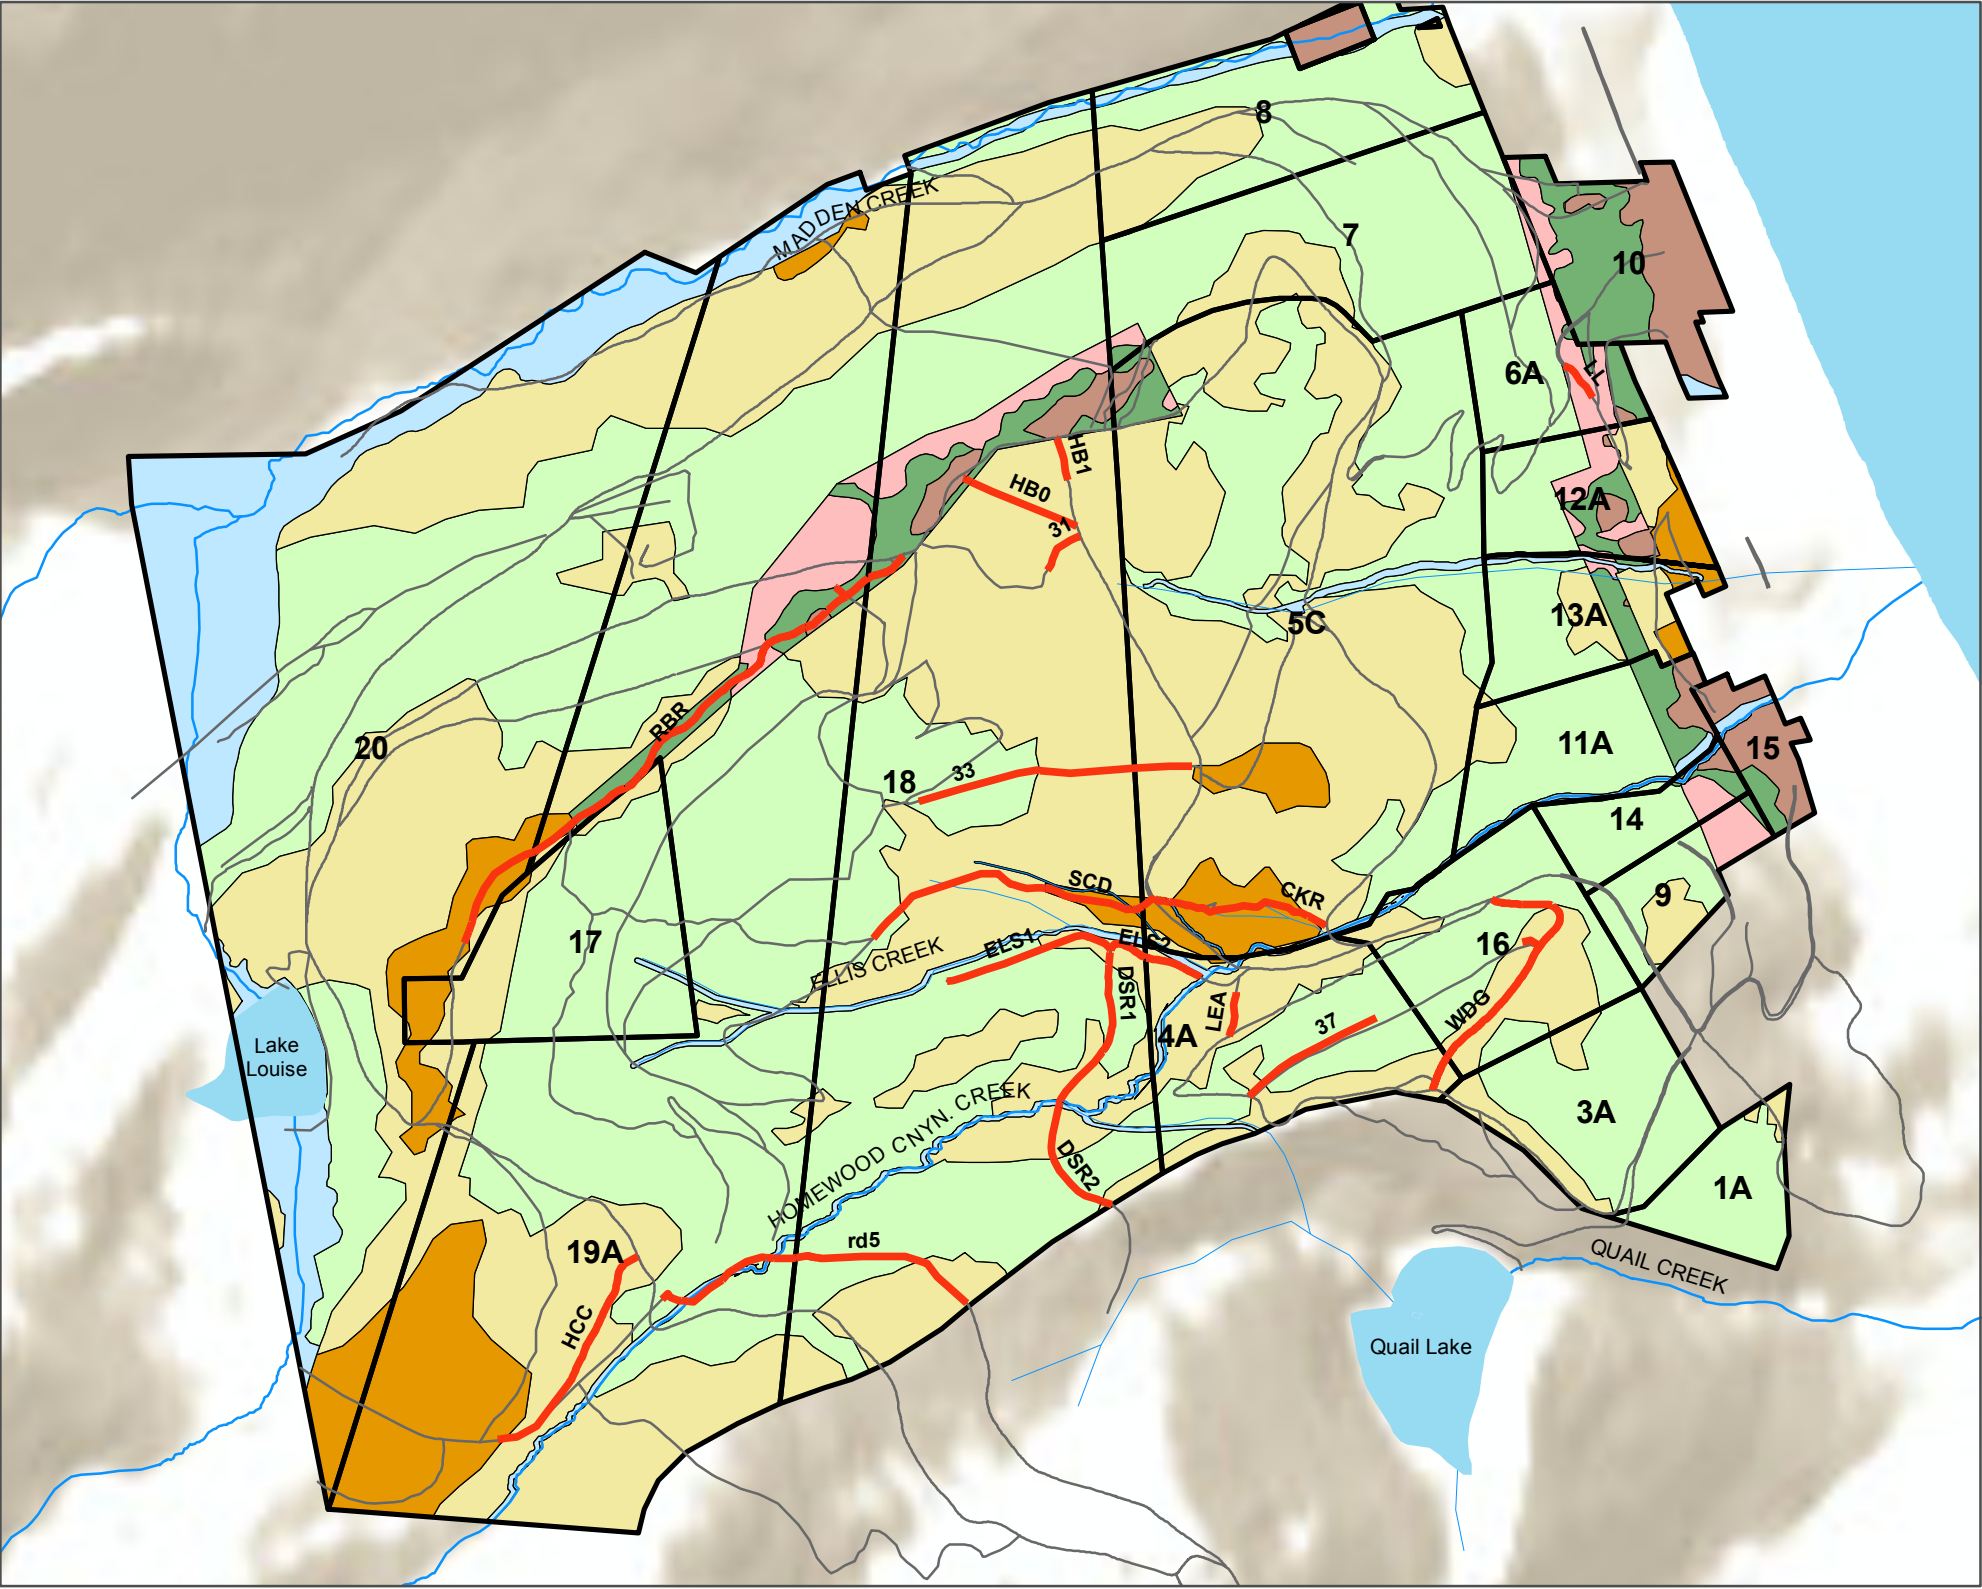
Homewood Mountain Resort Road Coverage Removal

A map showing the locations of the roads included in Tables 1 and 2 is shown on the following page.

This map shows coverage at Homewood Mountain Resort treated between 2006 and 2010.

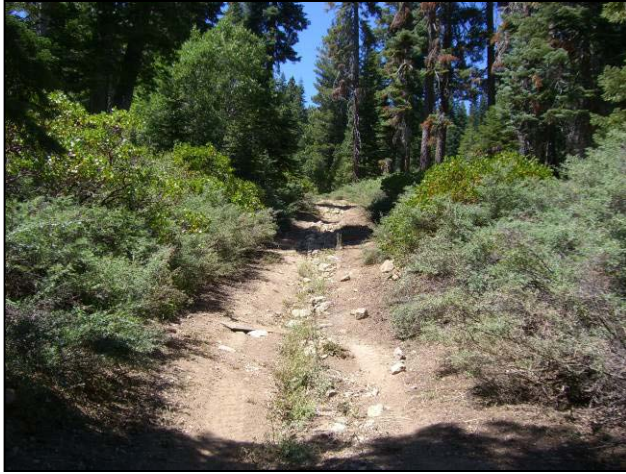
Creek Road

Pre-treatment - erosion is clearly visible.

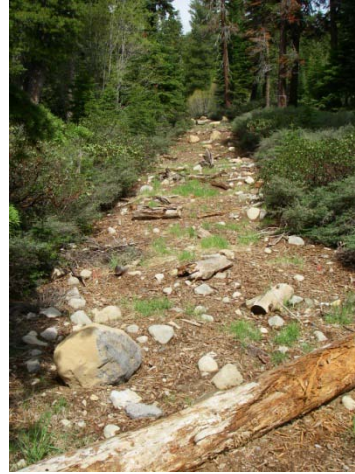
Post Treatment plus one growing season

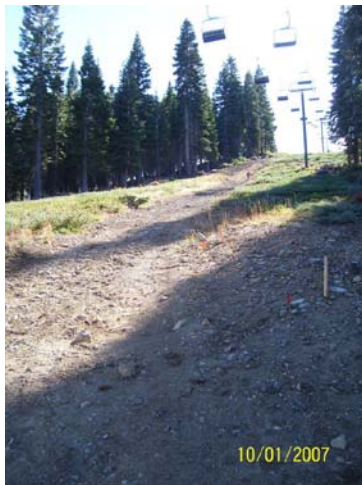
Upper Wedding Road

Pre-treatment – compacted dirt road

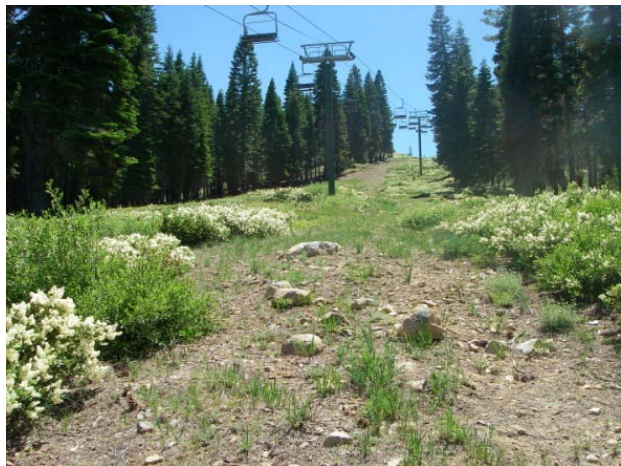
Post-treatment after two growing seasons

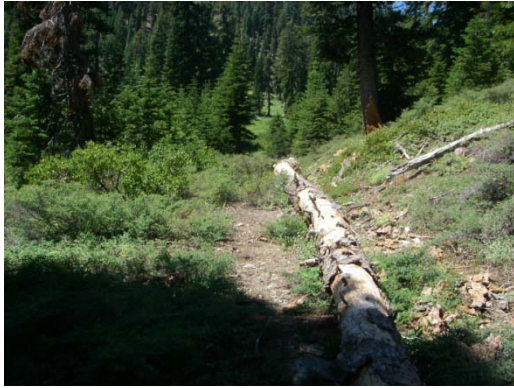
Diversion Spur Road

Pre-treatment – road prism and tracks visible

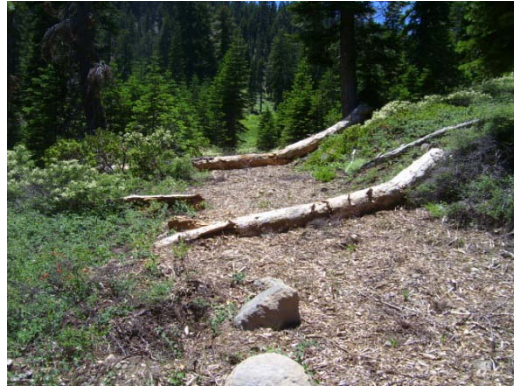
Post-treatment (same construction season as treatment)

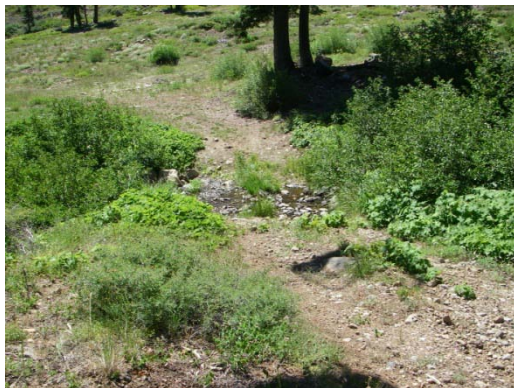
Ellis Road

Pre-treatment – near Homewood Creek crossing

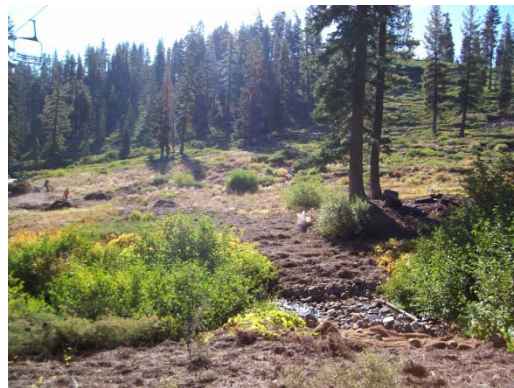
**Pre-treatment – near Homewood Creek crossing
(same season as treatment)**

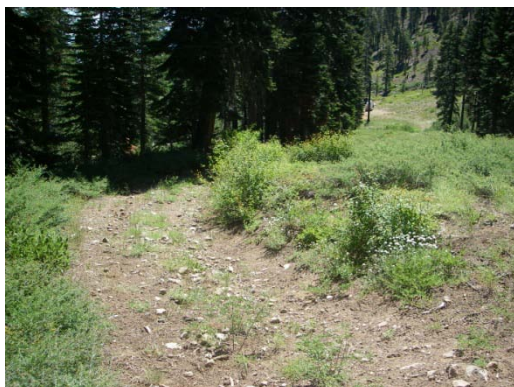
Pre-treatment – compacted road

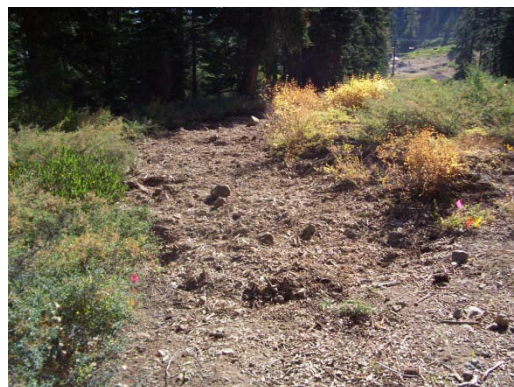
Post-treatment (same season as treatment)
